Rocky
Mountain
Conservancy

2022 Thumb Open Space Trail Report

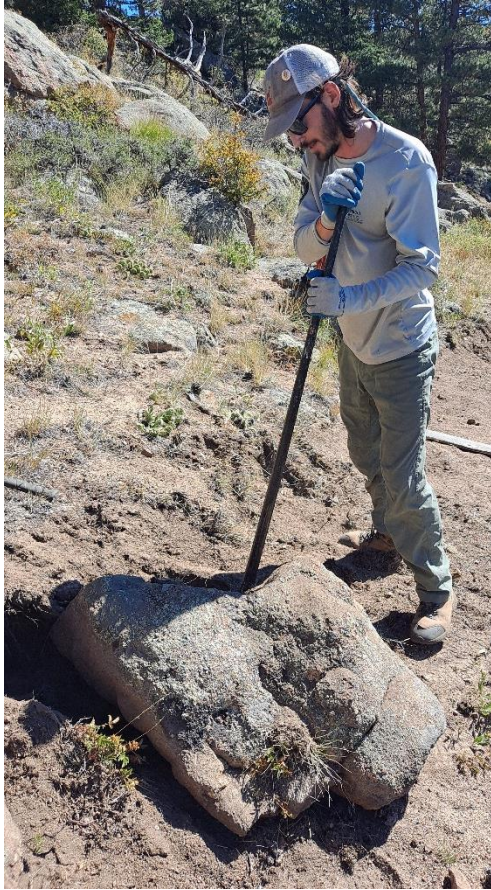
Nathan uses a rock bar to maneuver a boulder.

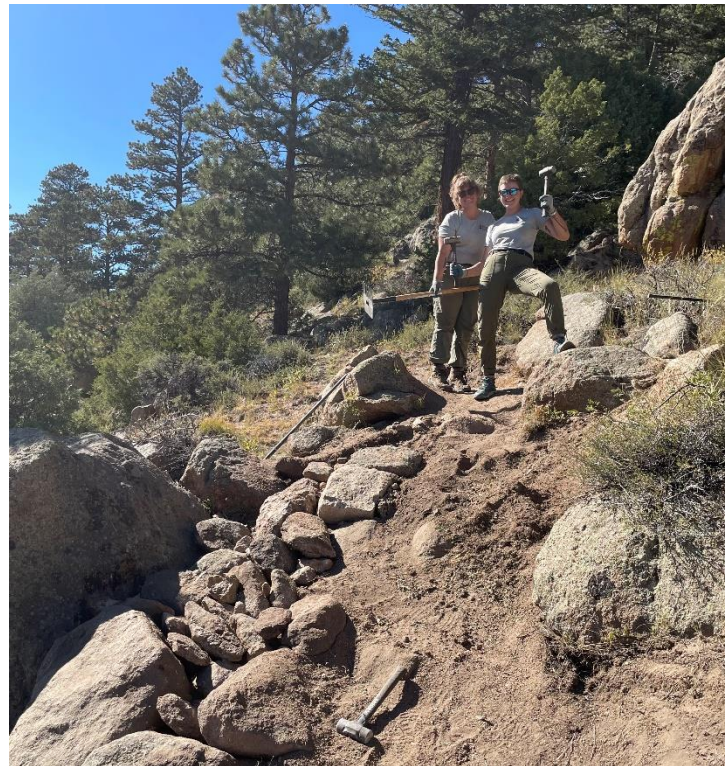
Charlotte and Grace pose after building a 15-foot section of rock wall.

In total, the crew made significant progress on the condition of the trail. The three-person RMC trail crew **brushed and cleared 3696 feet of trail corridor, widened 676 feet of tread, constructed 55 feet of rock wall,** and prepared dozens of small boulders and rocks to be used in future construction projects.

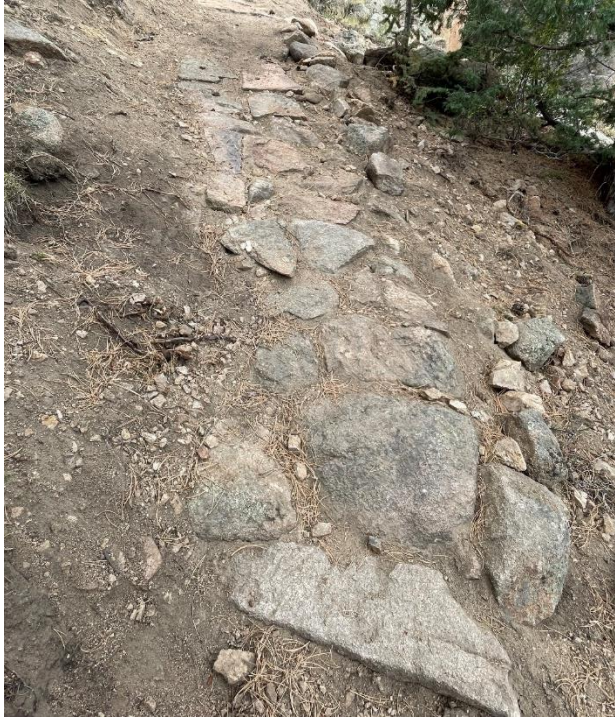
“Armoring” on switchbacks completed by Boulder Climbing Community’s Front Range Climbing Stewards.

Boulder Climbing Community's Front Range Climbing Stewards trail crew (led by Ryan Kuehn and Kiana Smith) guided a team of 9 volunteers to create nearly **40 feet of "armored" trail**, where large, flat-topped boulders are placed in the trail to create a durable and level walkway. This team focused primarily on the switchbacks near the start of the trail.

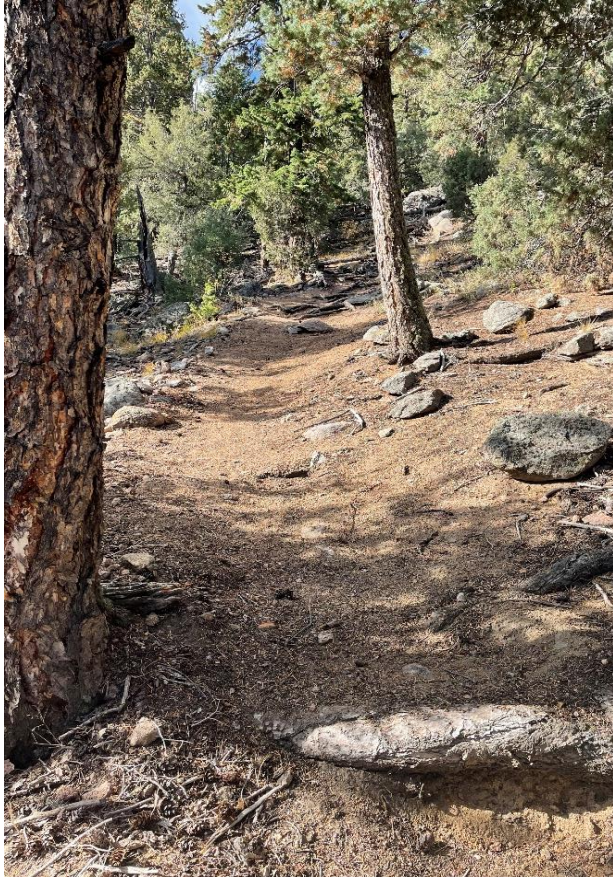
Freshly smoothed and widened trail corridor.

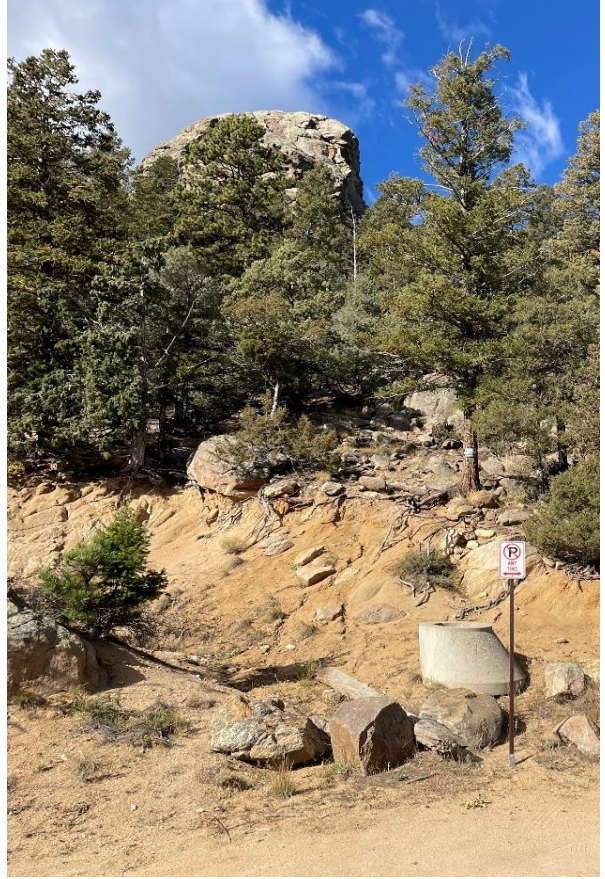
The Thumb from the start of the emergency access trail.

This emergency access trail is closed to the public. In an emergency, first responders or Search-and-Rescuers will be able to utilize this newly cleared, direct route to the base of the Thumb.

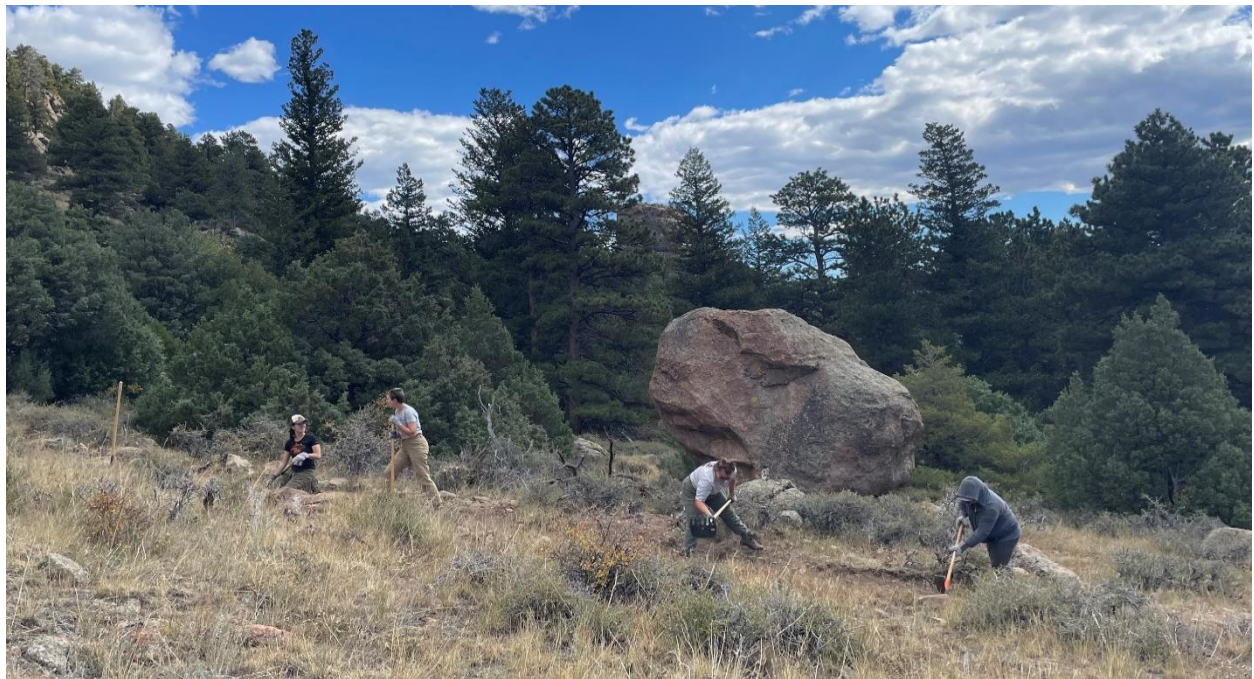
The crew hard at work widening a section of trail. The large boulder in the background is called the “Equalizer” boulder and is another climbing destination in the Thumb Open Space.

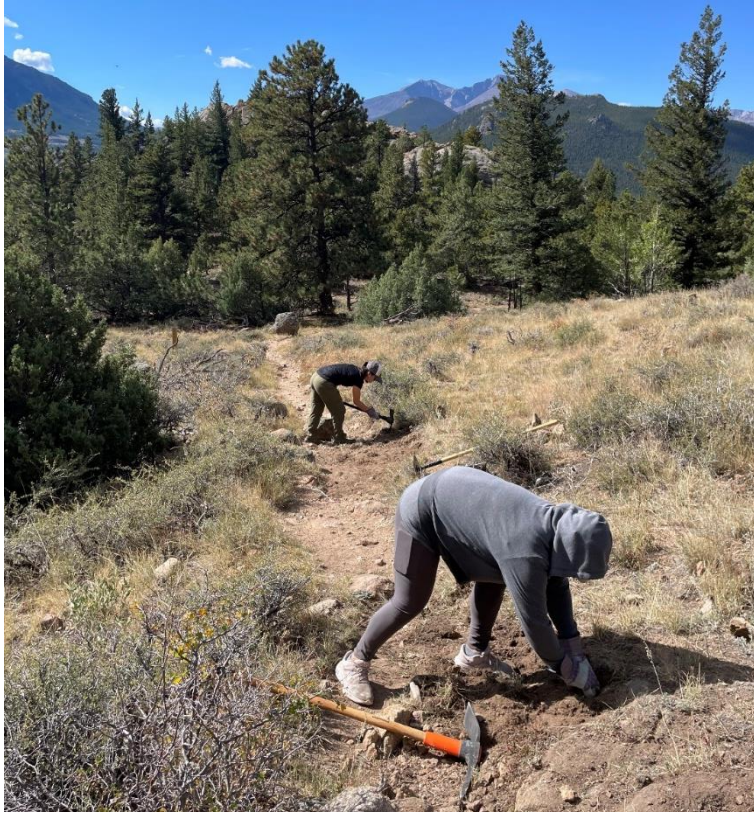
Maddie and Dalila use pick mattocks to remove rocks, shrubs, and widen the trail corridor.

In total, the RMC and EVLT
Volunteer Day widened over
120 feet of trail corridor at
Thumb Open Space.

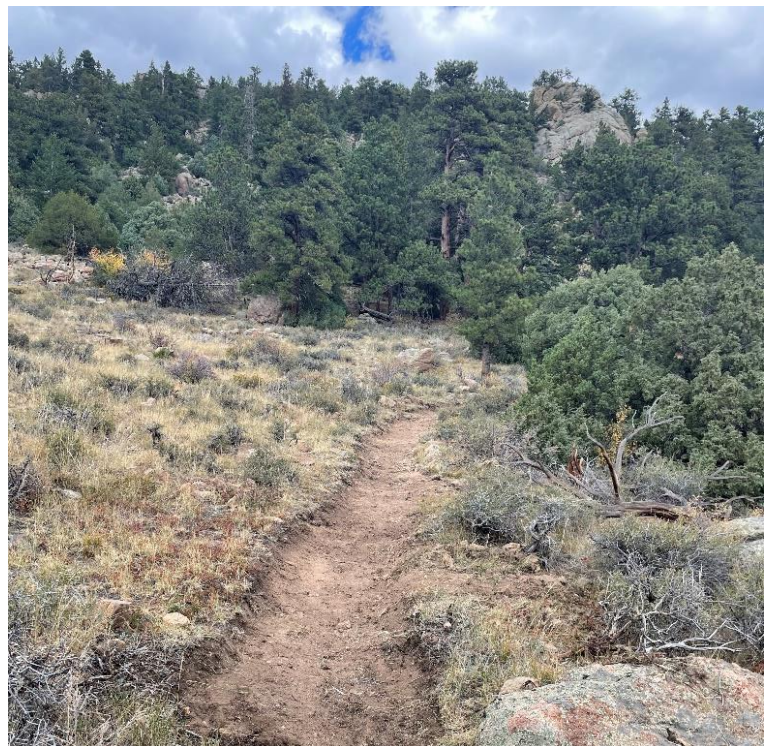
The finished product after a hard day's work.
